# MERIAM HOUSE

Minute Man National Historical Park  
Concord, Massachusetts

## Historic Structure Report

Barbara A. Yocum, Architectural Conservator  
Historic Architecture Program, Northeast Region  
National Park Service  
Lowell, Massachusetts

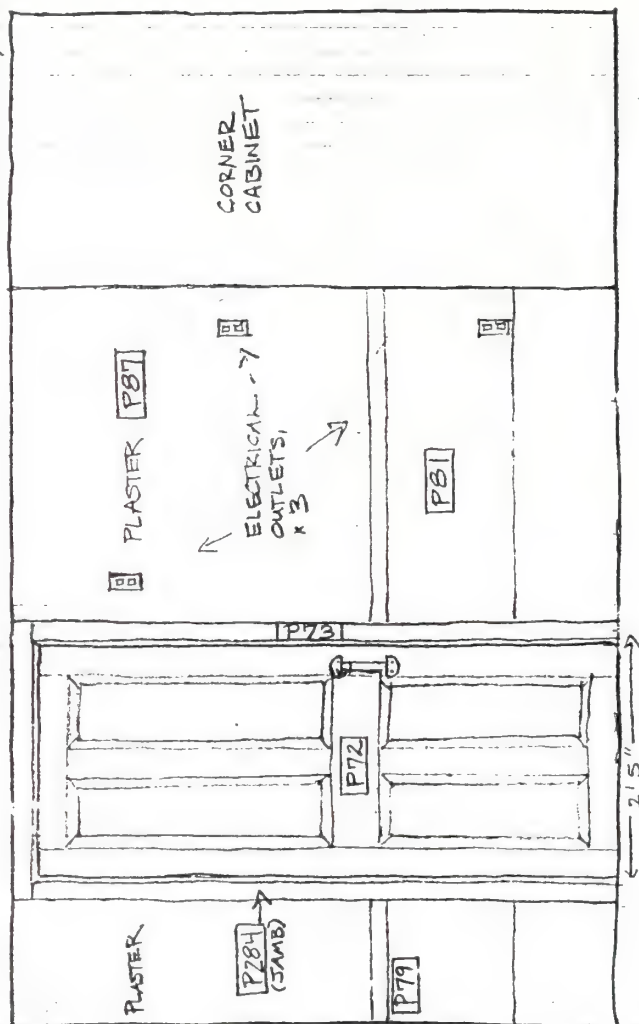
WOOD  
WAINSCOT IS  
3 HORIZ.  
BOARDS; TOP  
IS NARROW

DOORWAY TO  
RM 103

BOXED POSTS + GIRTS, WITH BEAD DETAIL

DOORWAY TO  
Rm 107

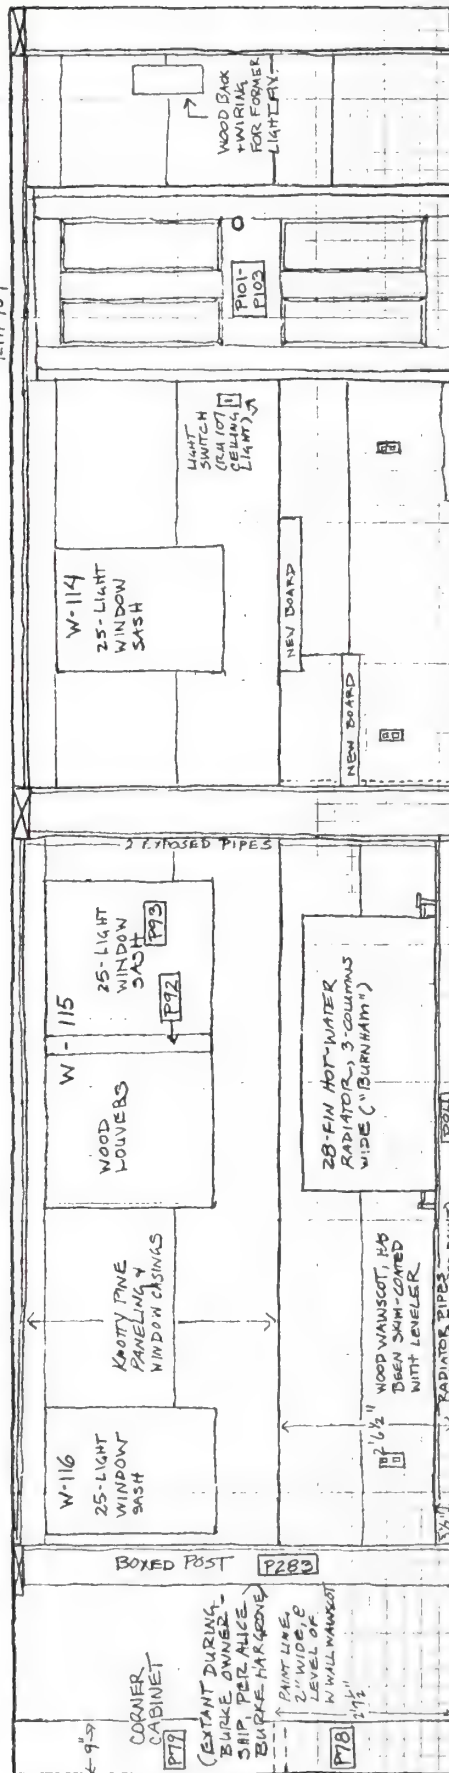
DOOR: MORTISED,  
RECESSED PANELS,  
BRASS KNOBS,  
EVIDENCE OF PREVIOUS  
LATCH HARDWARE +  
HINGES (REMOVED)  
DOOR MEASURES:  
2' 5 1/2" W  
6' 1/2" H  
1 1/4" TAIL

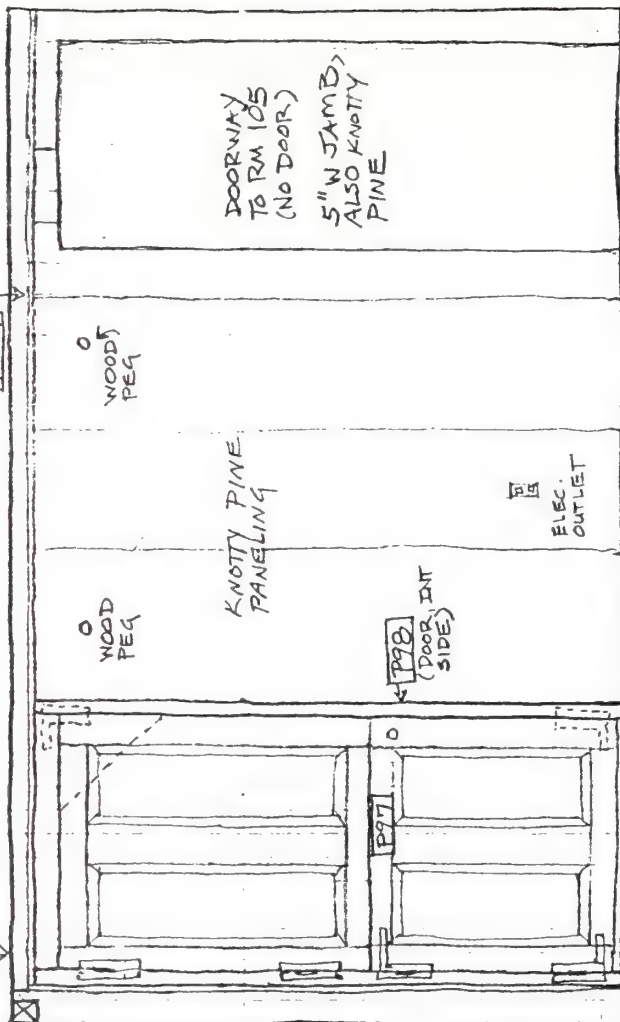
MIMA: MERIAM HS.  
 RM 104, EAST WALL  
 AUG. 17, 1993; B. Yocum  
 SCALE: 1/2" = 1'0"

FINISHES: CLOSET DOOR, INT  
 SHELVES, & POST: BEAM, PAINTED  
 RED (ALSO WALLS & FLOOR OF  
 LOWER CL); UPPER CL WALLS  
 PAINTED BLUE; KNOTTY PINE  
 IS VARNISHED.

BOXED POST & BEAM, W/ EDGE  
 BEAD DETAIL

CLOSET:  
 6 INT.  
 SHELVES

There are no fire detectors in Room 104. The control panel for the intrusion-protection system is in the closet at the east wall.

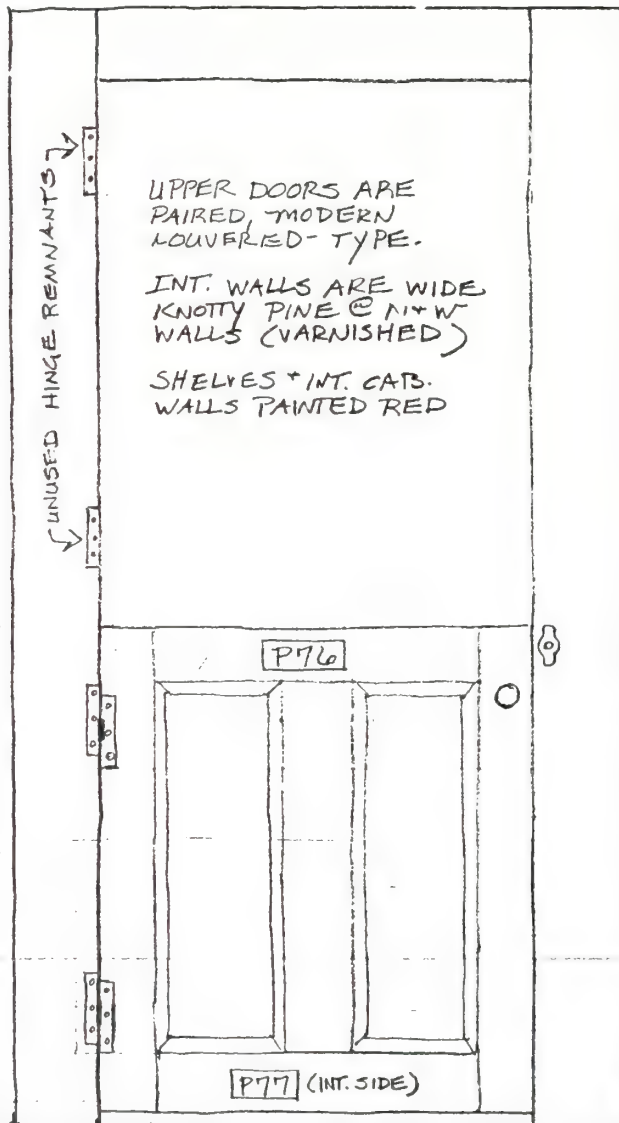
CABINET EXT IS  
PAINTED RED,  
EXCEPT LOUVERED  
DOORS THAT ARE  
UNPAINTED

WOOD SWIVEL LATCH

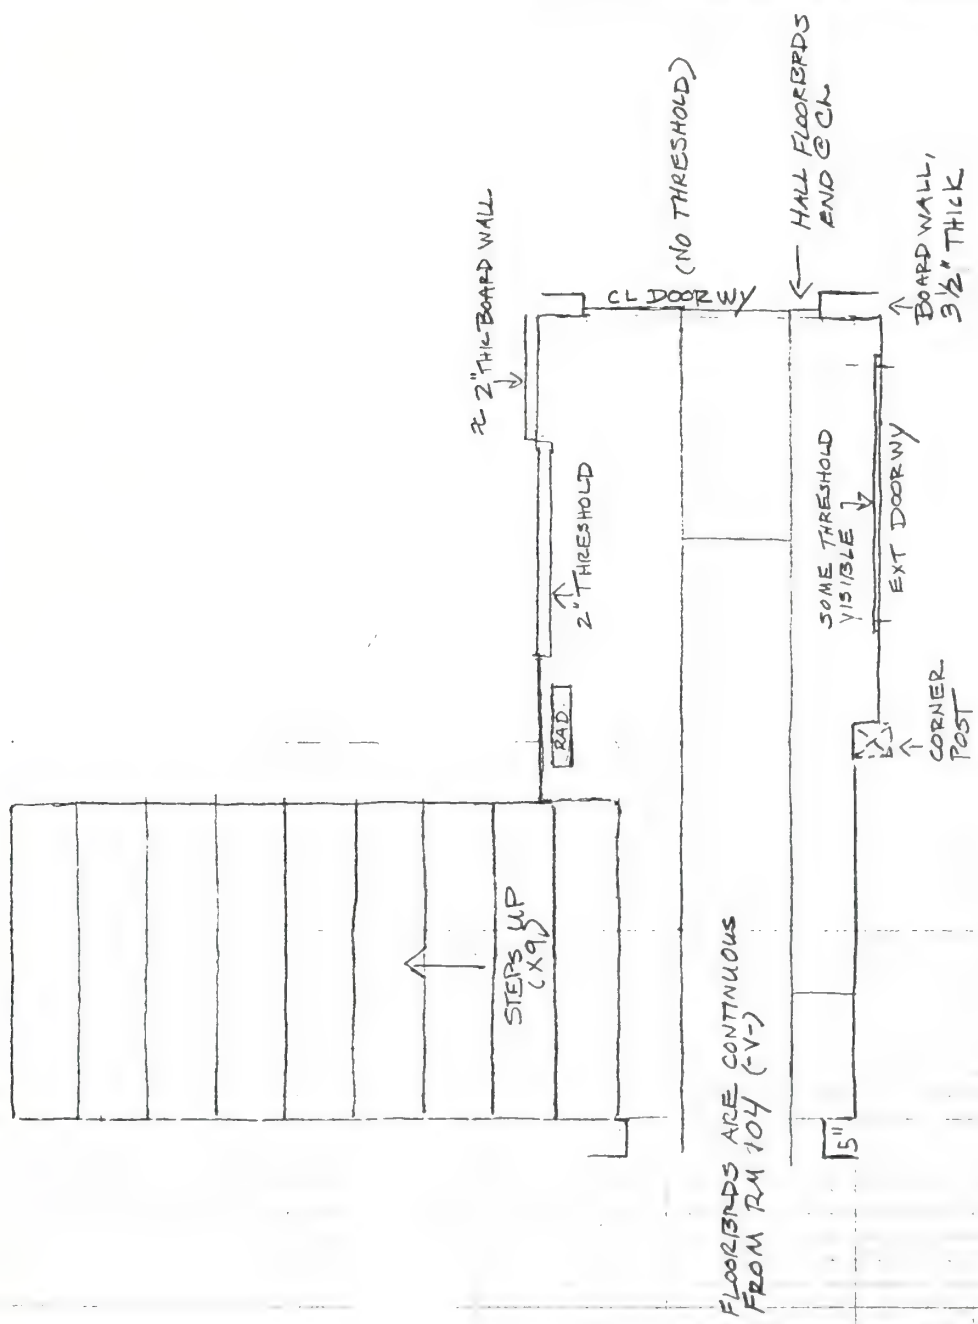
MIMA: MERIAM HS.  
 RM 105, FLOOR  
 AUG. 31, 1993; B. YOCUM  
 SCALE: 1/2" = 1'0"

FINISHES: WOODWORK IS PAINTED BROWN, PLASTER WALL IS PAINTED WHITE

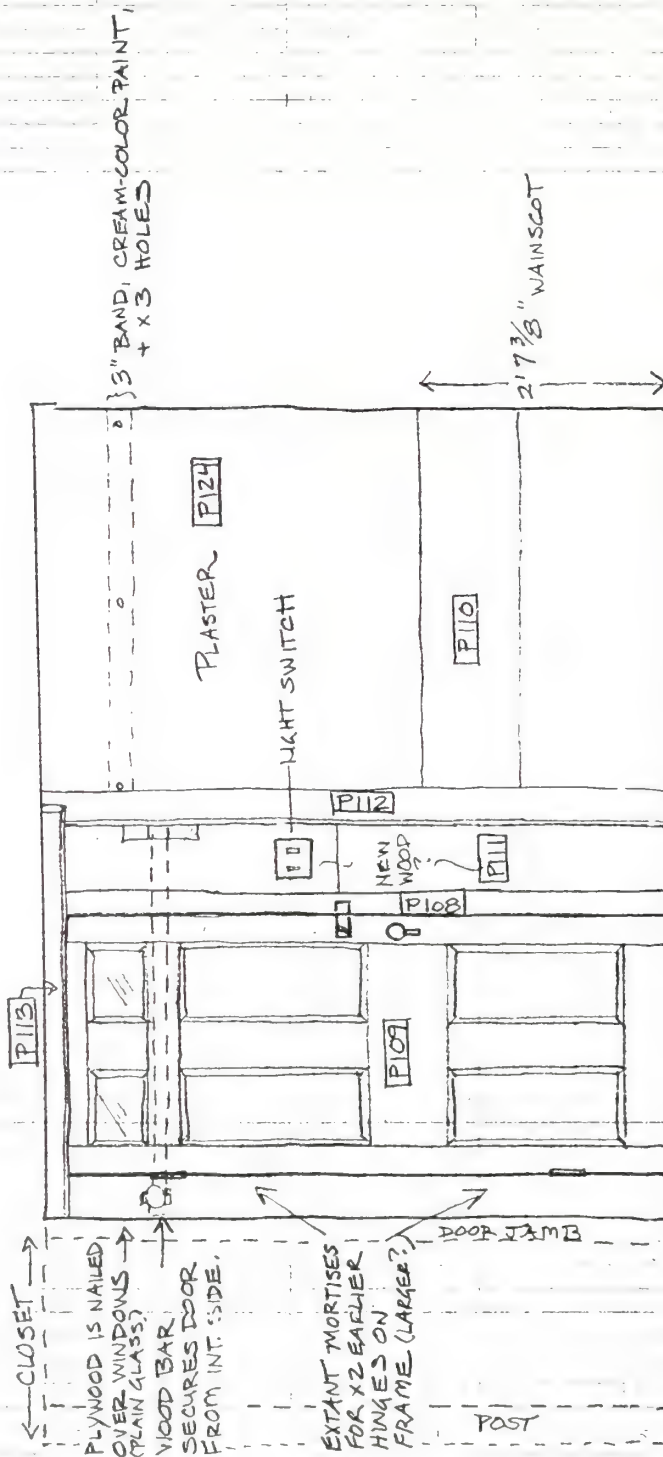
DOOR: RECESSED PANELS INT. SIDE, SAME PANELS EXT. SIDE. KNOB IS WOOD; "CORBIN" LATCH IS ABOVE KNOB. SHIMS HAVE BEEN ADDED @ TOP + W SIDE TO FIT EXISTING OPENING. NOT INCLUDING SHIMS, DOOR MEASURES:

2'8 1/2" N  
6'2 3/8" H  
1 9/16" THICK

WALL + DOOR ARE T467  
 WOOD PANELING,  
 PAINTED LT. BROWN.  
 HARDWARE REPROD.?

MODERN  
 QUARTER-  
 ROUND TRIM →

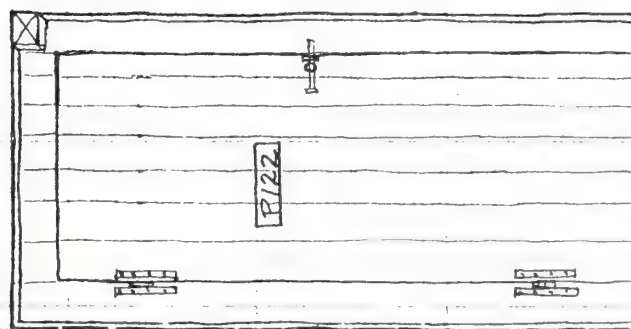
LIFT LATCH,  
 ROOM SIDE  
 ONLY

↑  
 EAST WALL

BACK SIDE OF  
 5 1/4" MATCH BOARDING.

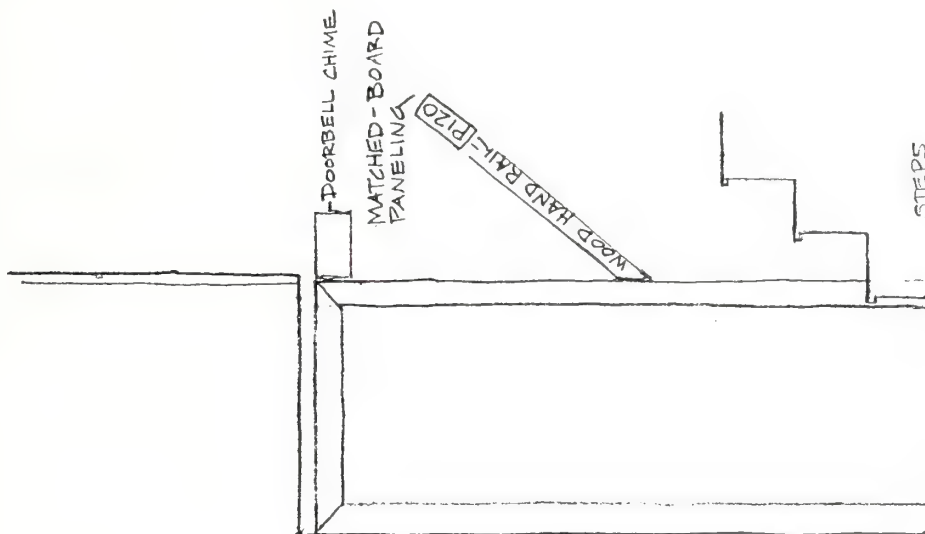
DOORBELL CHIME

MATCHED-BOARD  
 PANELING

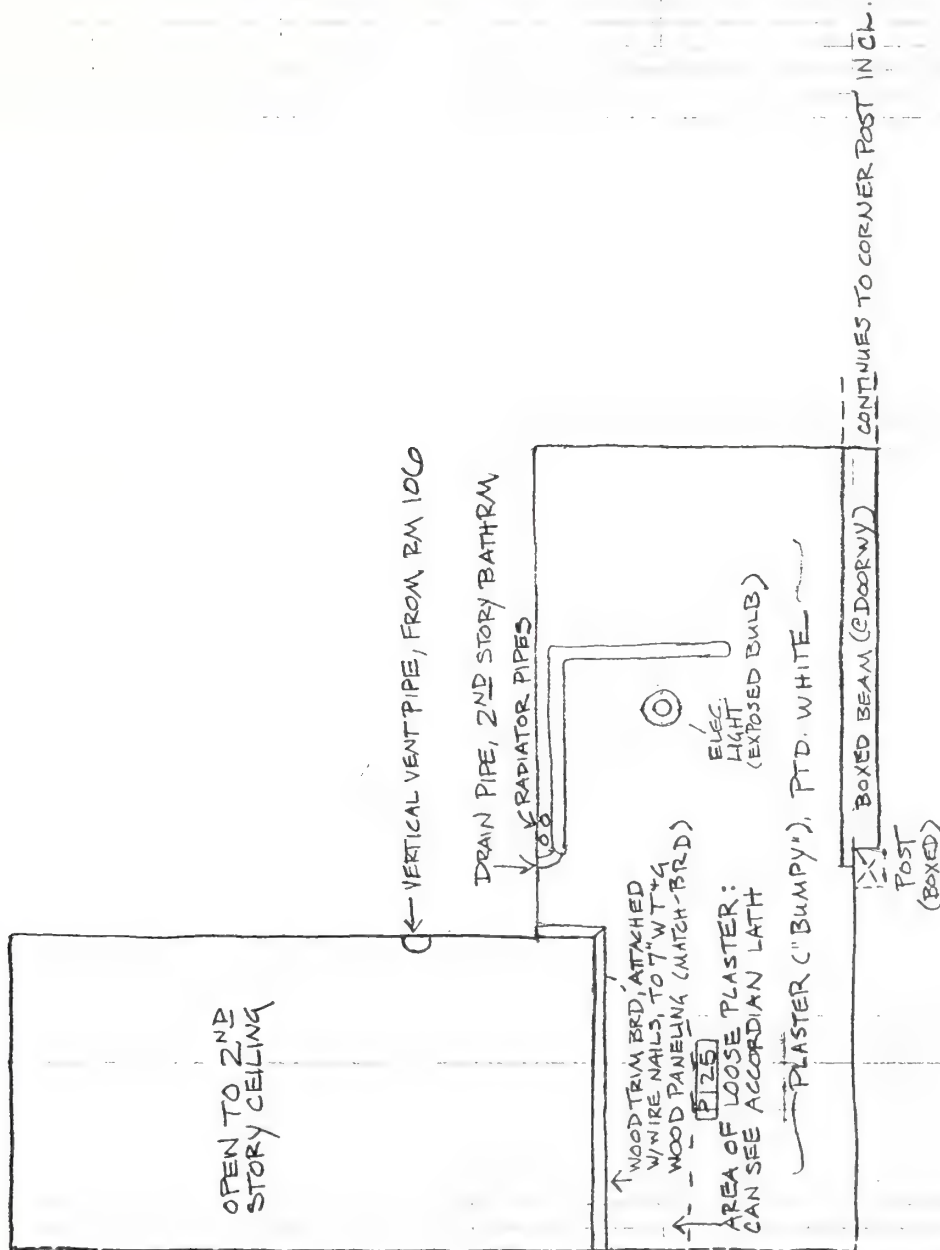
Rm 105, CEILING

ARCHITRAVE: SIMPLE BEAD  
DETAIL. ARCH + DOOR  
HAVE THICK PAINT BUILDUP.

NOTE: NO OLD  
TRIM BRD @ STAIRWAY  
CEILING -- CEILING  
OPENED @ LATER  
DATE?

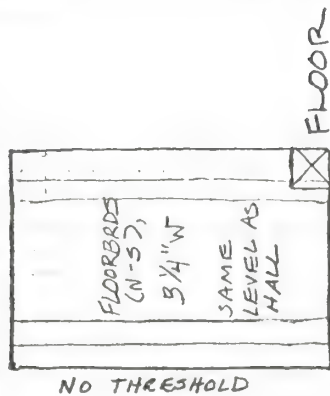
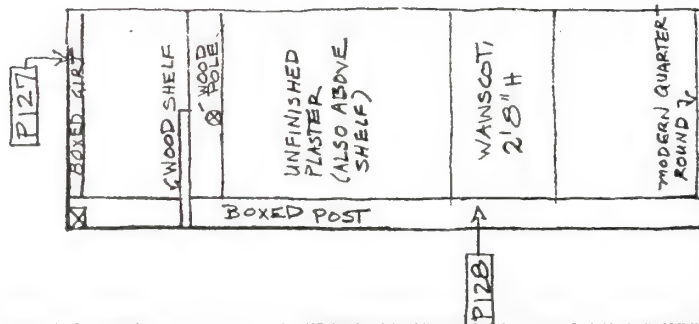
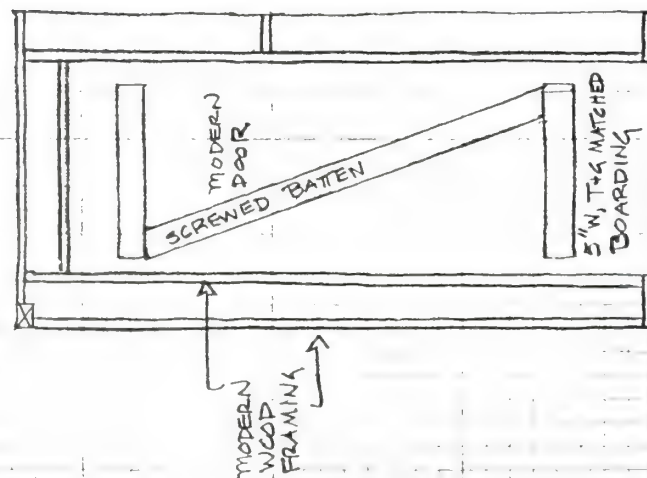
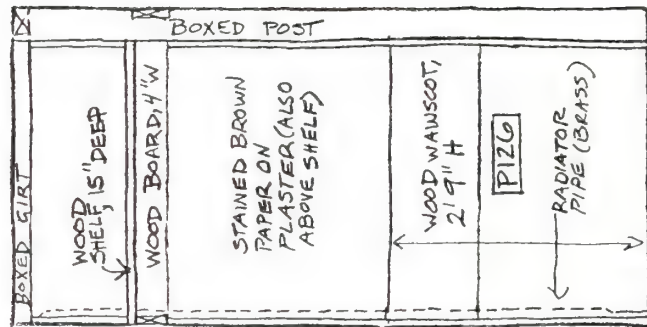
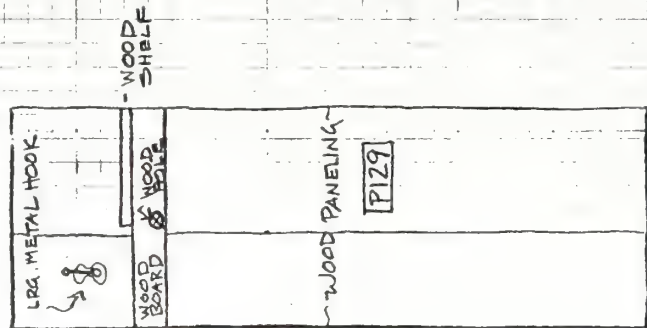
TRIMA: MERIAM HS  
RM 105a  
AUG. 31, 1993; B. YOCUM  
SCALE: 1/2" = 1'0"

FINISHES:  
PAINTED BROWN: FLOORBOARDS, WAINGSCOT, N. WALL PANELING, SHELF, BOXED POSTS, GIRTS, SHELF SUPPORTS  
PAINTED WHITE: CEILING  
WALLPAPER: EAST WALL ONLY  
VARNISH: WOODWORK

NOTE: ONE 2ND STORY FLOOR BRD, ABOVE EARLIER LANDING, IS CHARR'D (REUSED?); IT MEASURES 8'0" WIDE. WIDTH OF STAIRWAY APPEARS TO HAVE BEEN SAME AS EXISTING STAIRWAY ( $\approx 3'5\frac{1}{2}"$ )

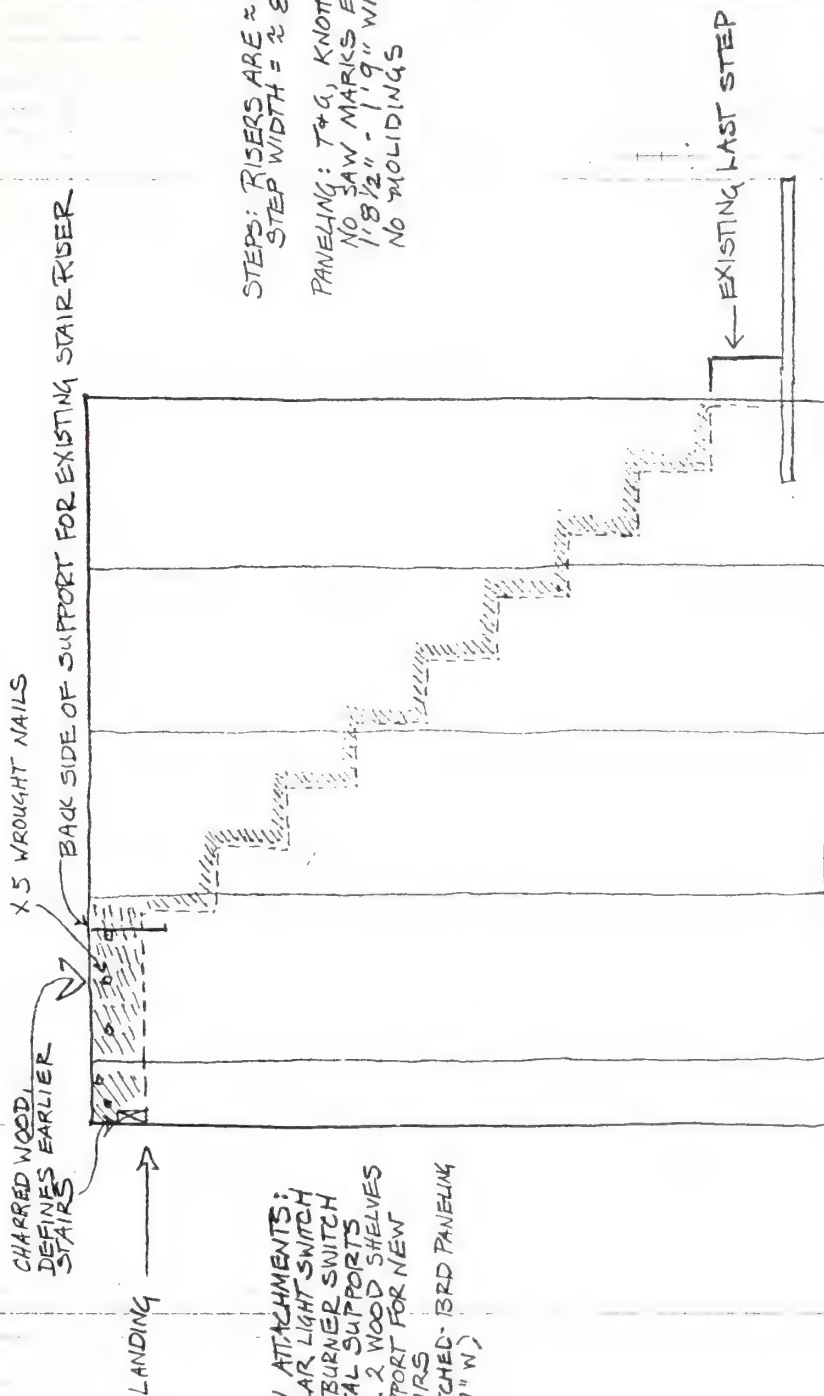
STEPS: RISERS ARE  $\approx 9"$  H,  
STEP WIDTH =  $\approx 8"$   
PANELING: T&G, KNOTTY PINE  
NO SAW MARKS EVIDENT  
 $1'8\frac{1}{2}" - 1'9"$  WIDE;  
NO MOLDINGS

MODERN ATTACHMENTS:  
• CELLAR LIGHT SWITCH  
• OIL BURNER SWITCH  
• METAL SUPPORTS  
FOR 2 WOOD SHELVES  
• SUPPORT FOR NEW  
STAIRS  
(MATCHED 1" BRD PANELING  
 $\approx 7" W$ )

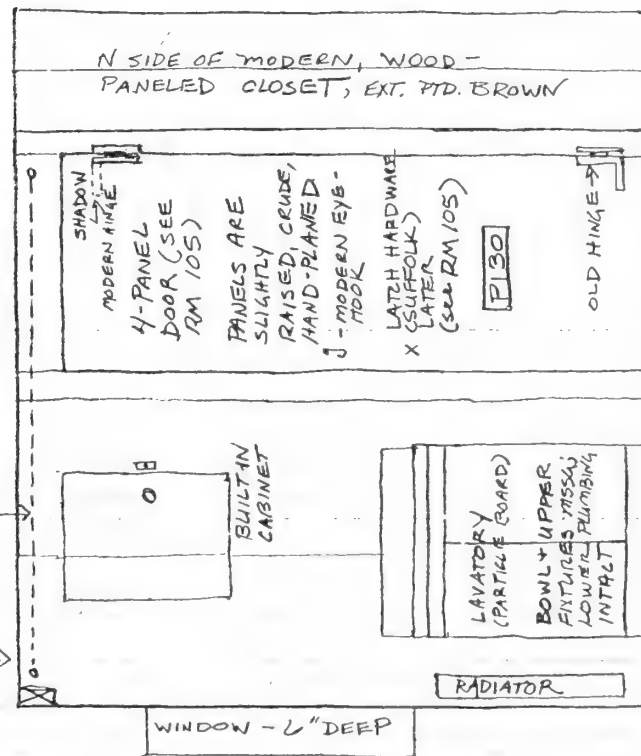
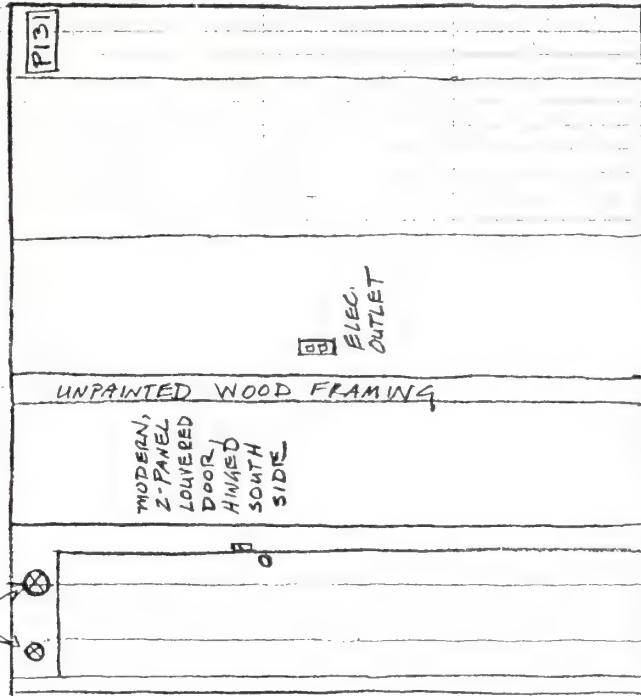
RM 106

SOIL PIPES

RADIATOR PIPE (BRASS)

DOOR: REUSED, PTD BROWN,  
SUFFOLK LATCH, MORTISED;  
MEASURES: 3 1/4" W  
6' 2 1/8" H  
7/8" THICK

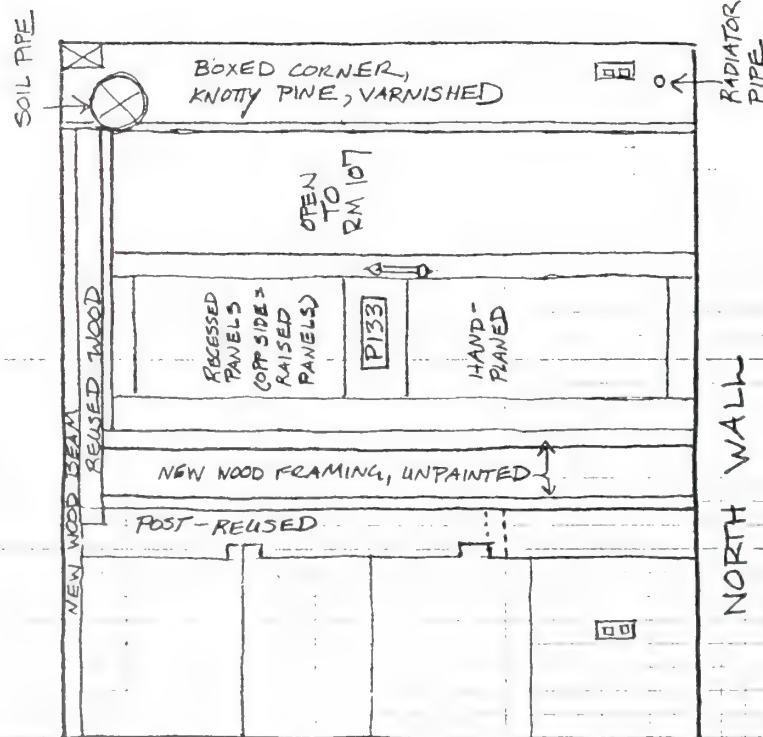
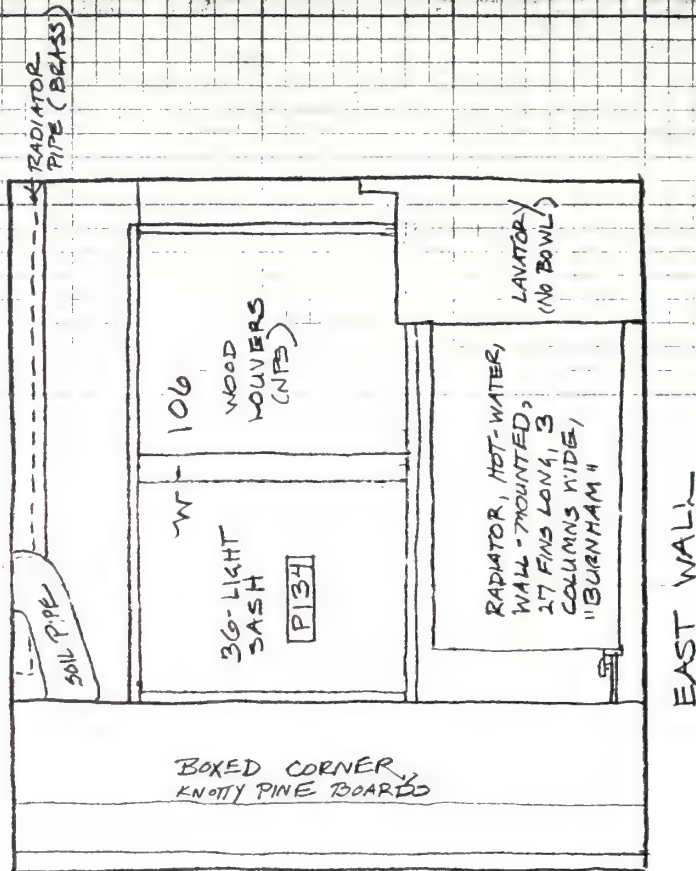
MIMA: MERIAM HS.  
RM. 106  
Aug. 31, 1993; B. Yocum  
SCALE: 1/2" = 1'0"

ALL WOODWORK @ EAST WALL  
IS VARNISHED KNOTTY  
PINE, INCLUDING BOXED GIRT

RADIATOR  
PIPE (BEARS)

FLOORING: SHEET LINOLEUM, (ALSO IN KITCHEN) ON PLYWOOD BASE

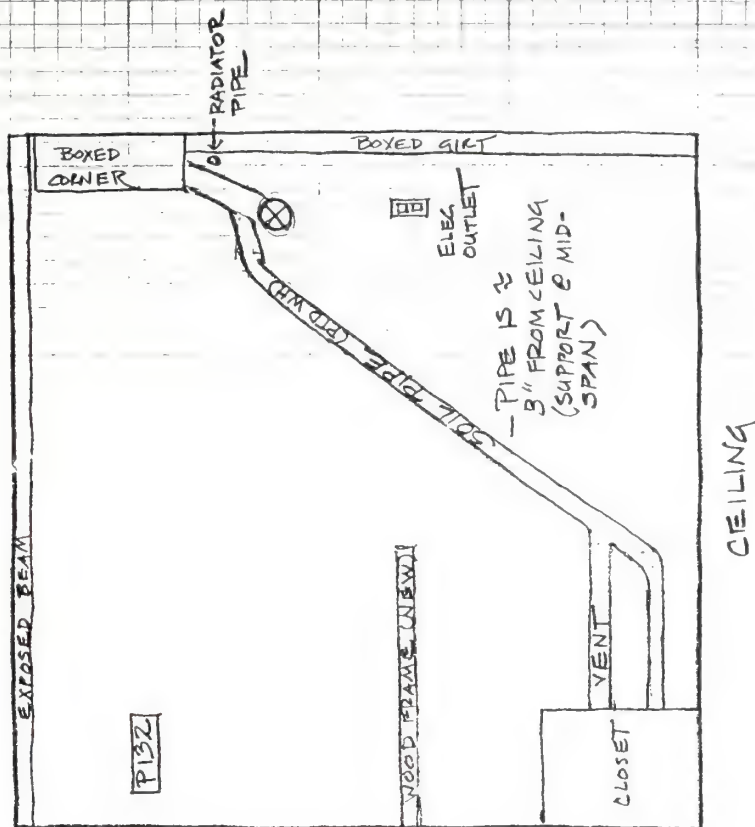
CEILING

CEILING: PLASTER, PAINTED WHITE (LOOKS OLD)

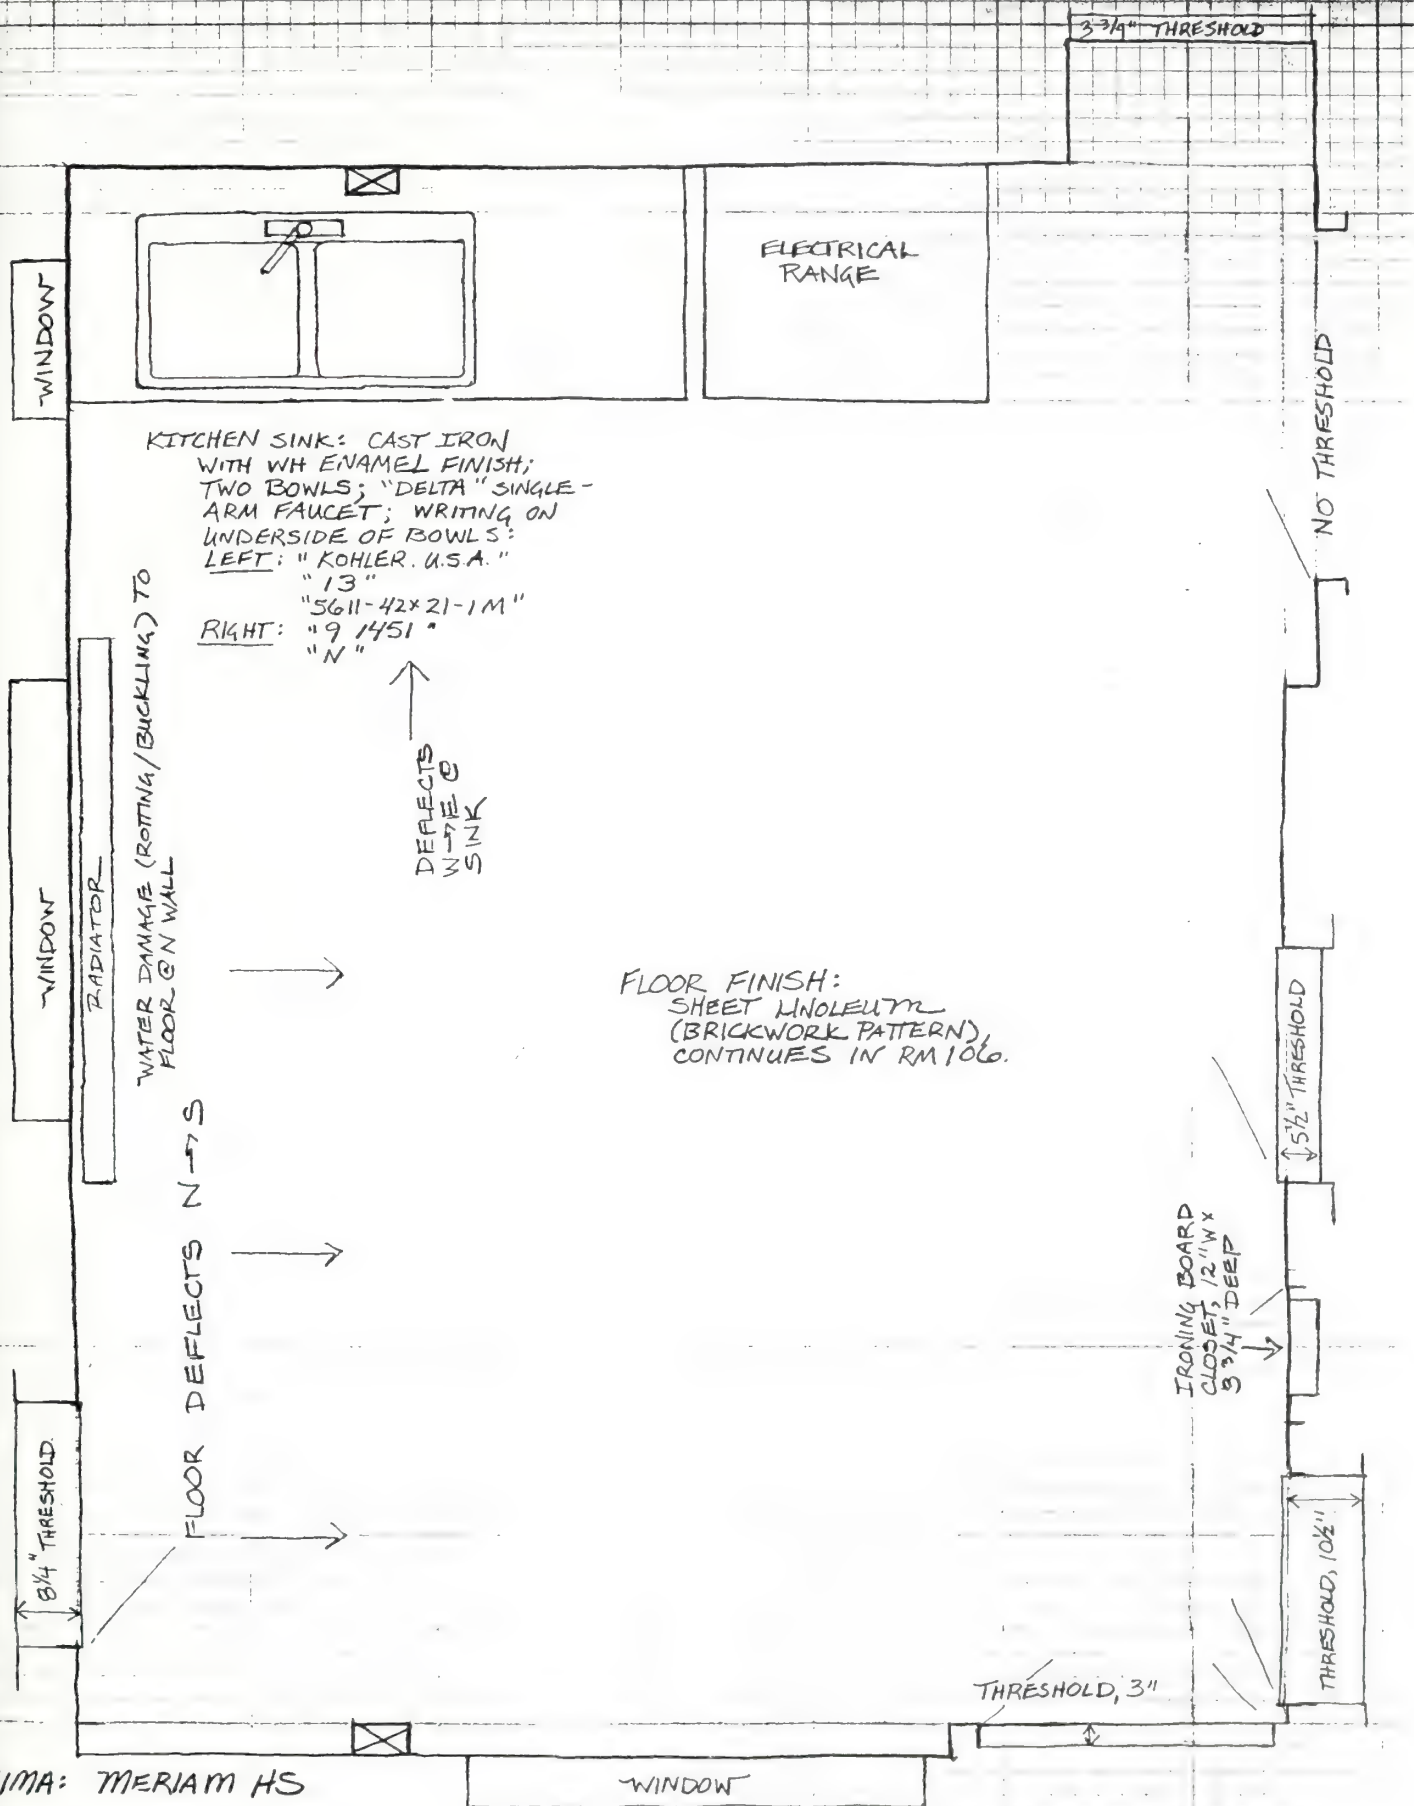
NMA: MERIAM HS  
RM 107, FLOOR  
SEPT. 30, 1993; B. Yocum  
SCALE: 1/2" = 1'0"

DOORWAY: TO RM 106; HAS ONE DOOR ONLY; DOOR IS MORTISED; PANELS ARE RAISED & MOLDED RM 101 SIDE (RECESSED RM 206); MORTISES ON WEST SIDE FOR 2 1/2" L. 3-SCREW HINGES; SEE RM 106 FOR DOOR DIMENSIONS

DOORWAY: TO SMALL CLOSET CONTAINING BUILT-IN IRONING BOARD; DOOR IS KNOTTY PINE (SINGLE BOARD)

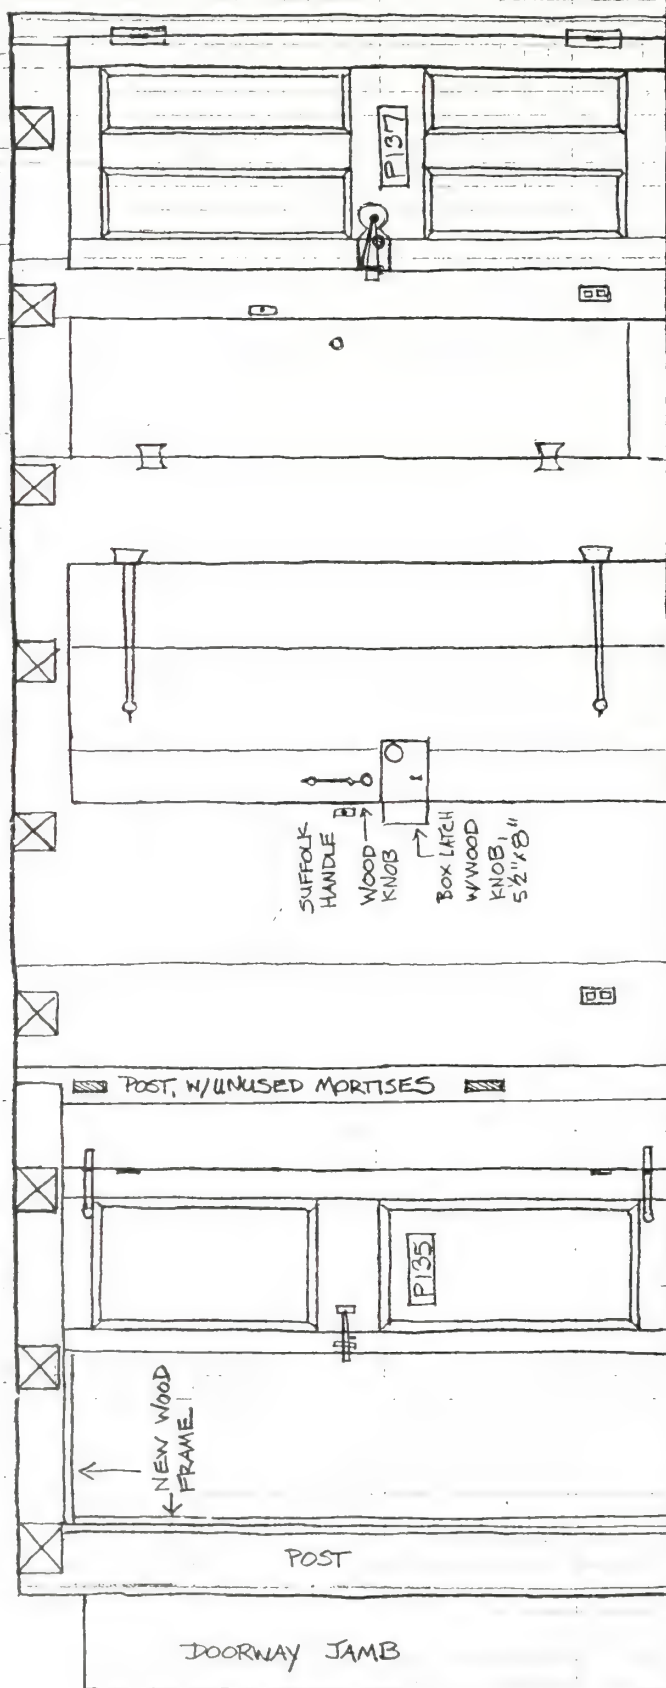
DOORWAY: TO CELLAR, MADE OF WIDE PINE BOARDS; ATTACHED TO OPP. SIDE IS AN OLD 4-PANEL DOOR, WHICH IS MORTISED; W/ EVIDENCE OF FORMER NORFOLK LATCH (= RM 202 DOORS) & HINGE MORTISES; PANELS ARE RAISED & UNMOLDED; DOOR MEASURES: 2' 5 1/2" W 6' 3/8" H 1" THK.

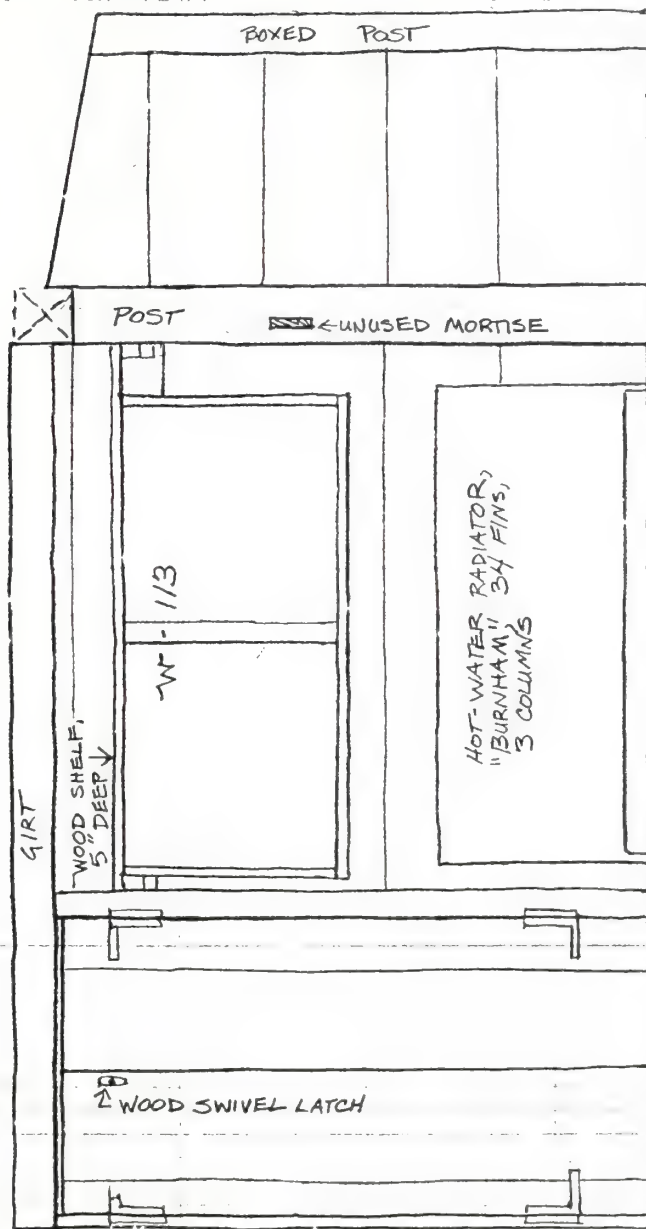
FINISHES: ALL SURFACES, INCLUDING THE RADIATOR ARE VARNISHED.

WALL SURFACE: HORIZONTAL, KNOTTY-PINE BOARDS (REUSED, BASED ON EMPTY NAIL HOLES)

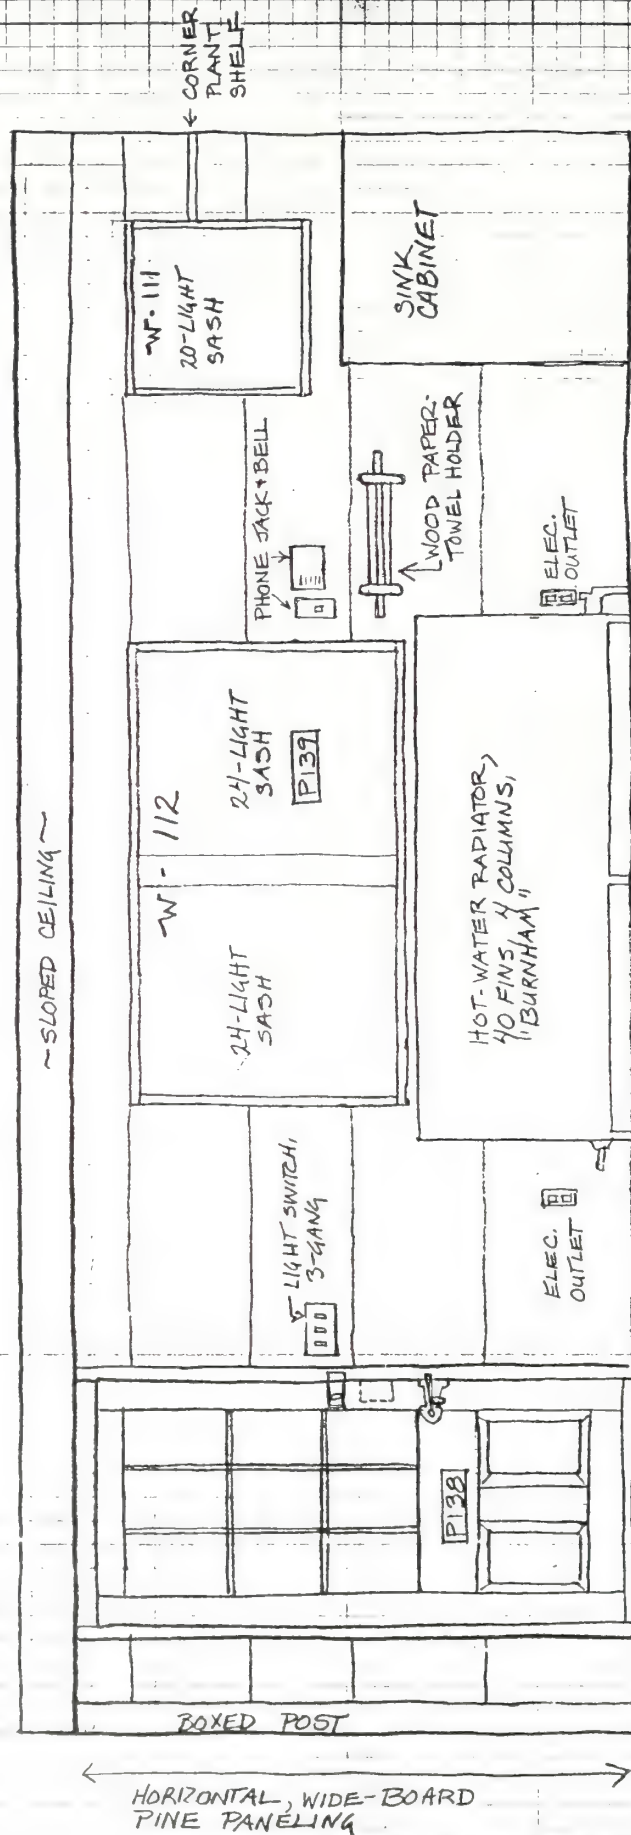
WALL PANELING: WIDE, KNOTTY-PINE  
BOARDS; PINE ALSO CASES  
NW POST.

FINISHES:  
VARNISH -- WALL PANELING, CORNER  
SHELF, POST BOXING, SINK  
CABINET, RADIATOR + TOWEL HOLDER  
RED PAINT -- DOOR + WINDOW  
SASH

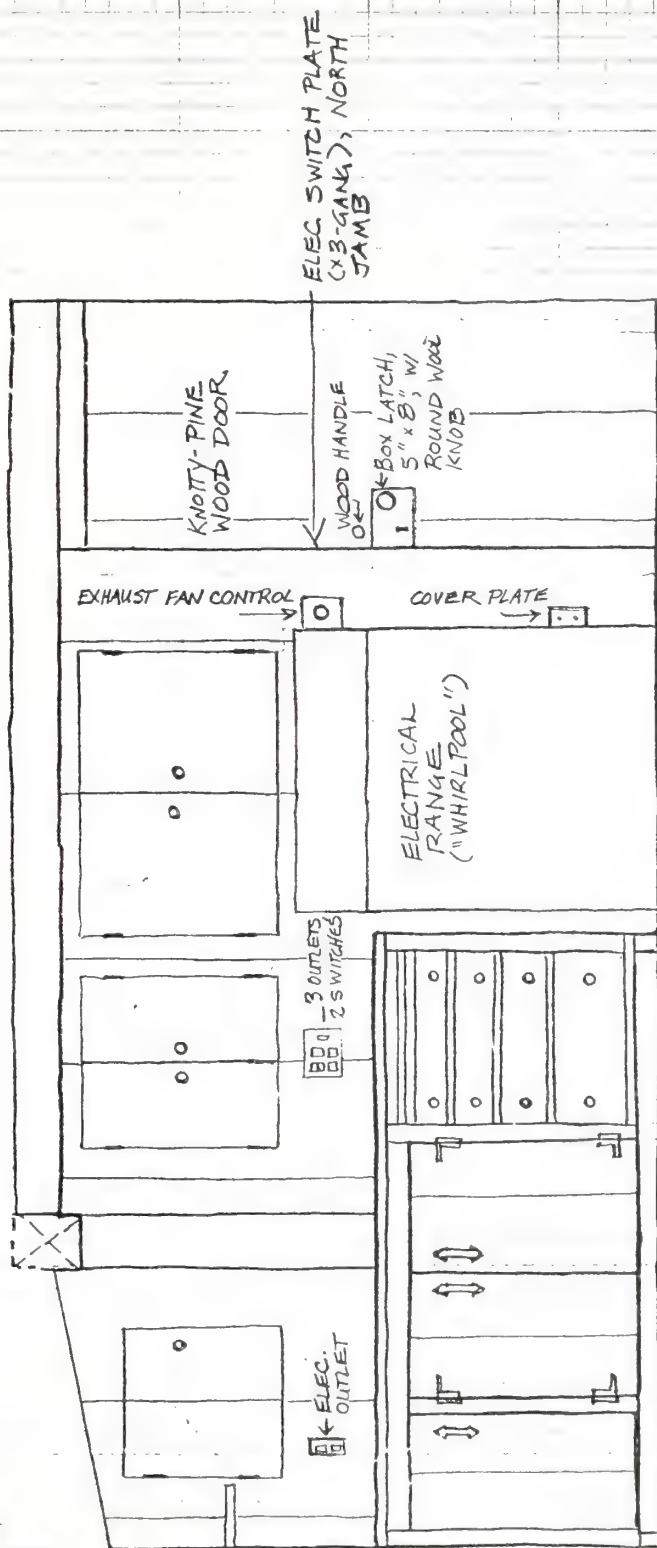
THINA: MYRIAM HS  
RM 107, EAST WALL  
SEPT. 29, 1993; B. Yocum  
SCALE: 1/2" = 1'0"

CABINETS: ALL WOOD, WITH WOOD  
KNOBS; UPPER DOORS ARE  
DESIGNED AS PART OF WOOD  
SIDING

WOOD PANELING: WIDE, REUSED  
KNOTTY PINE, INSTALLED  
VERTICALLY.

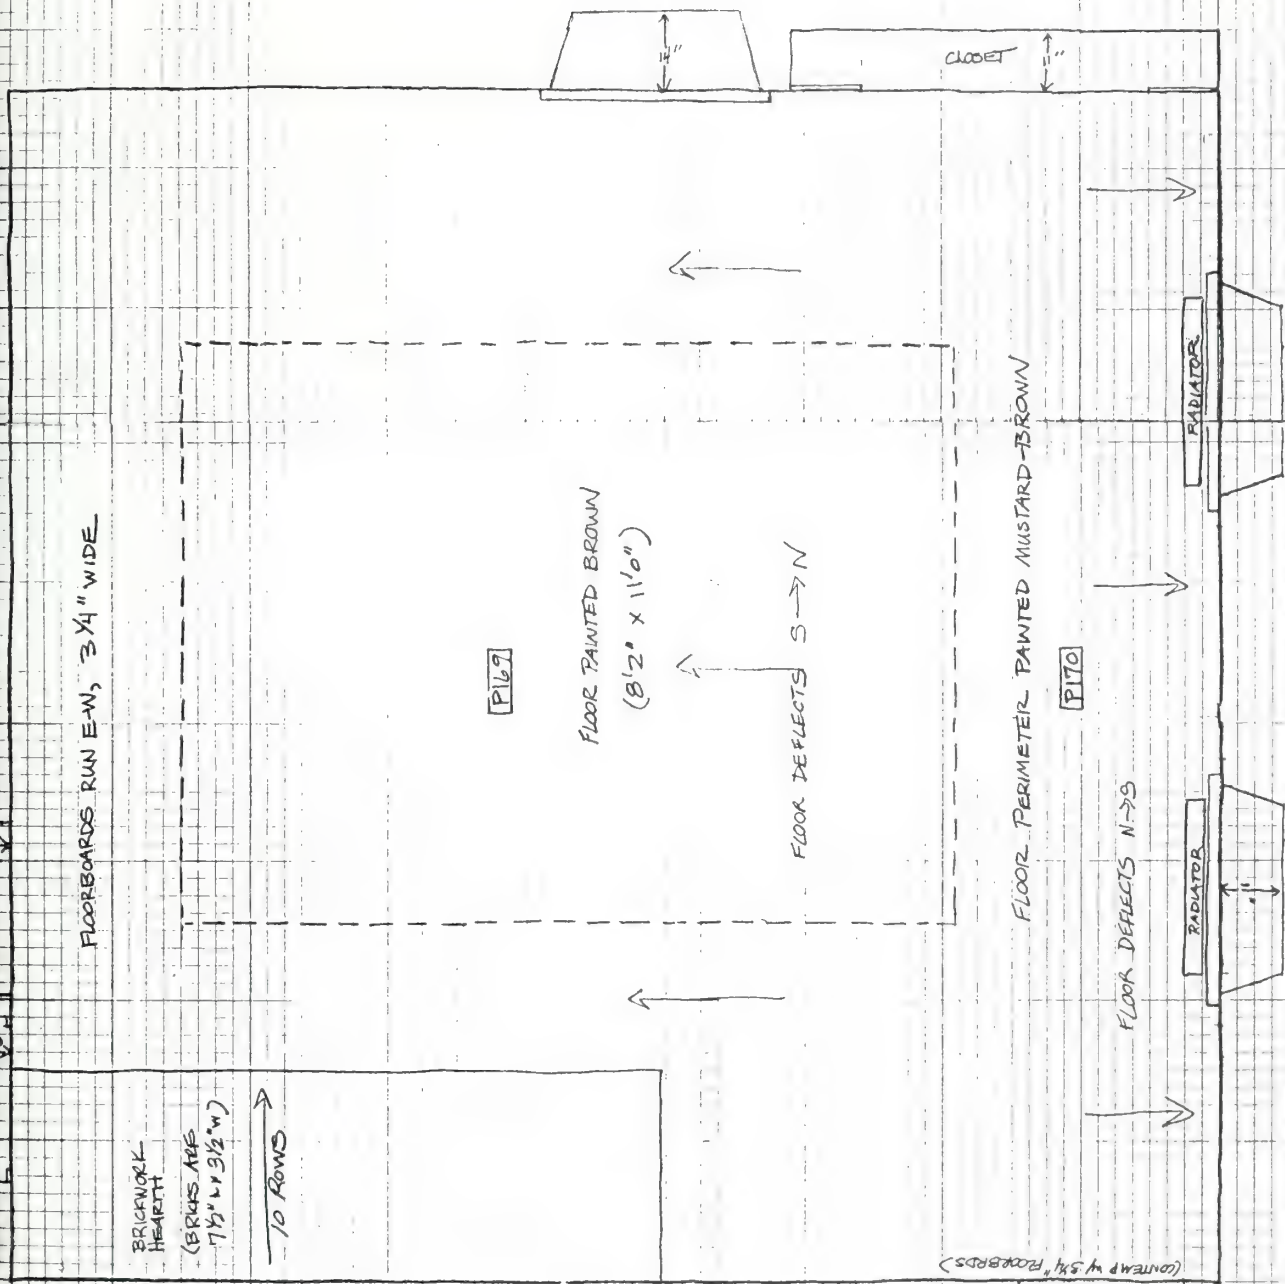
MIRIAM: MIRIAM HS  
 RM 108, FLOOR  
 SEP 7, 1983; 3:10 PM  
 Reduced drawing, not to scale.  
 SCALE: 1/2" = 1'0"

FINISHES: WALLS + 7 1/2" BSBRD PTD. WHITE;  
WINDOW WOODWORK, 4 1/2" BSBRD +  
RADIATORS PTD. RED

PLASTER: LOOKS OLD (BUMPS + IRREGULARITIES),  
BUT GOOD CONDITION; PTD. WHITE  
(ORIGINAL PLASTER?)

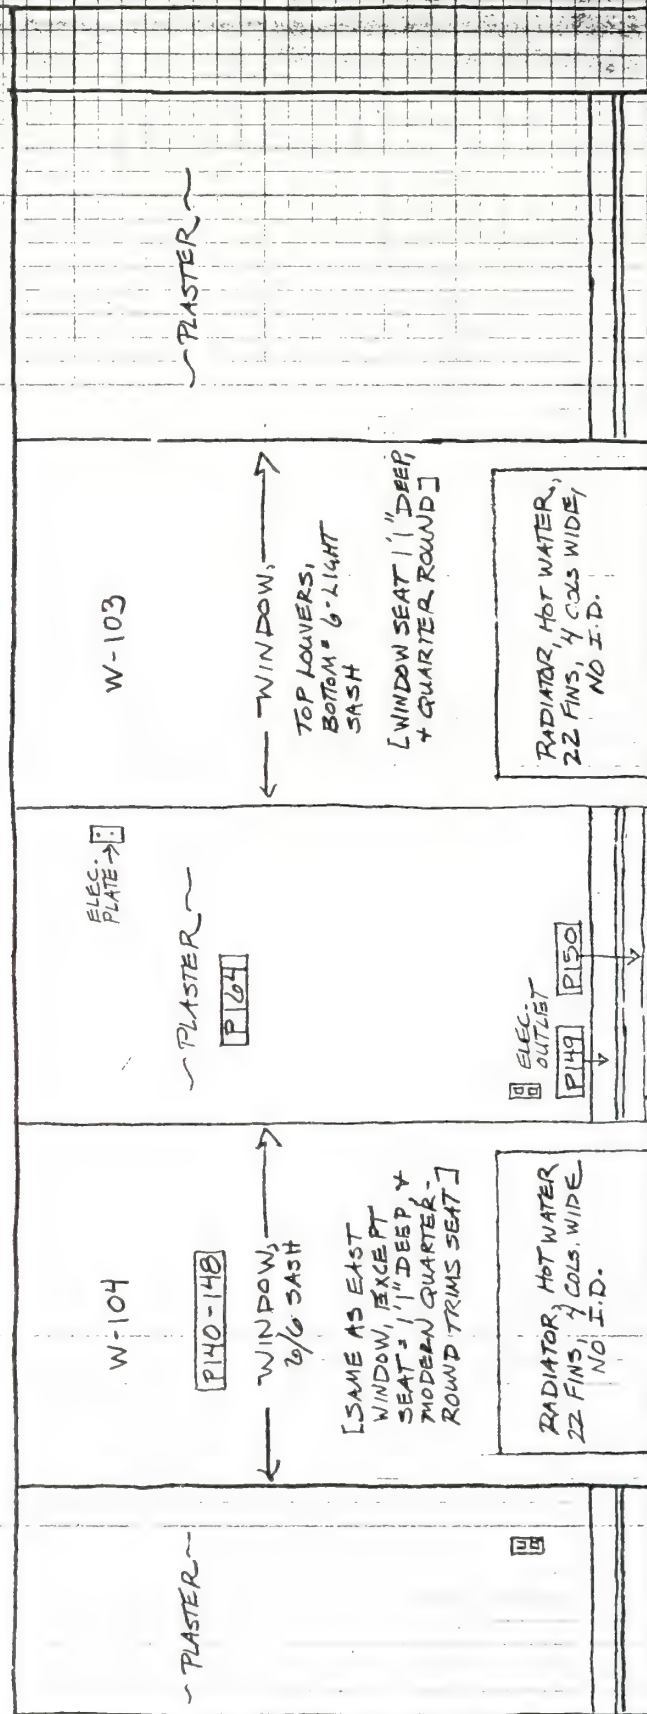
Wall depth @ doorway = 11"

WINDOWS: SIMILAR TO EAST WALL, EXCEPT WINDOW SEAT IS SHALLOWER + PAINT + ARCHITRAVE MOLDING IS INTACT. ALSO, SASH ARE SET HIGHER IN THE WALL (NO BEAM TO OBSTRUCT); CONSEQUENTLY, APRON IS 3" HIGHER (1 1/2" VS. 8 1/2") + ARCHITRAVE HEADER TOUCHES CEILING. (PLASTER COVERS A PORTION OF THE EDGE MOLDING).
